SURVEY OF FLUE GAS DESULFURIZATION SYSTEMS. WILL COUNTY STATION, COMMONWEALTH EDISON COMPANY

EPA-650/2-75-057-i

SURVEY OF FLUE GAS DESULFURIZATION SYSTEMS

WILL COUNTY STATION, COMMONWEALTH EDISON CO.

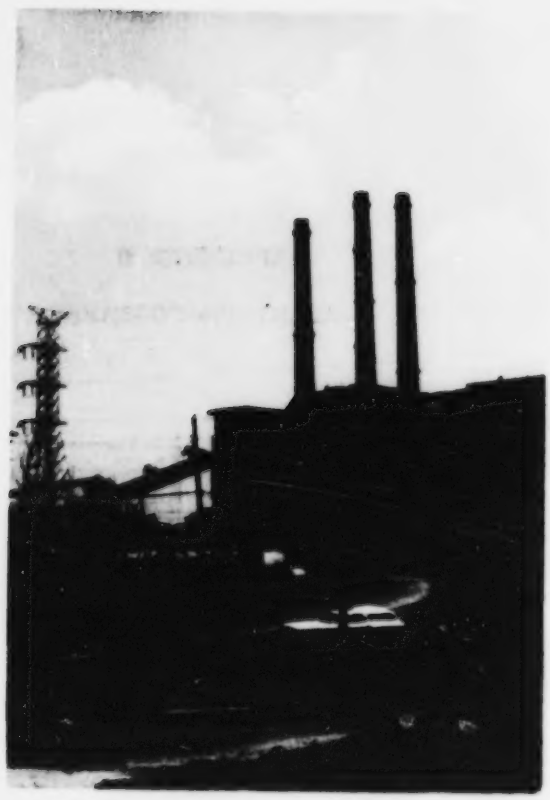
Photo No. 1 General view of the Will County power house showing the coal conveyor (foreground) and the limestone conveyor in the background.

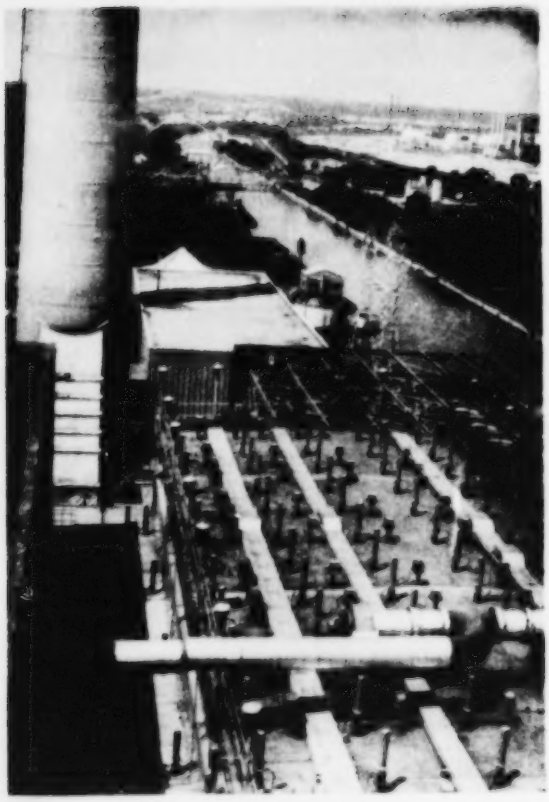
Photo No. 2 View from top of the boiler building looking north towards the ship and sanitary canal. The FGD modules are housed in the building shown behind the electrostatic precipitator structure. The peak of the limestone storage pile can be seen in the background.

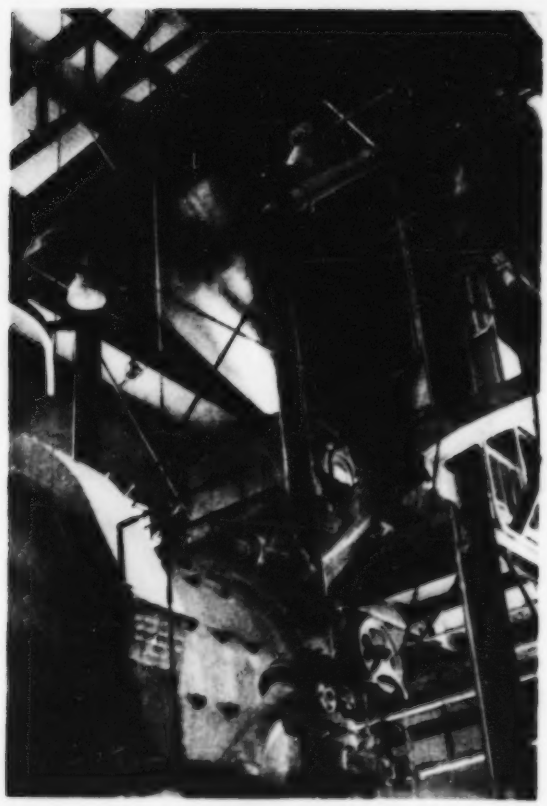
Photo No. 3 View inside the limestone grinding building showing the bottom of the limestone storage silo.

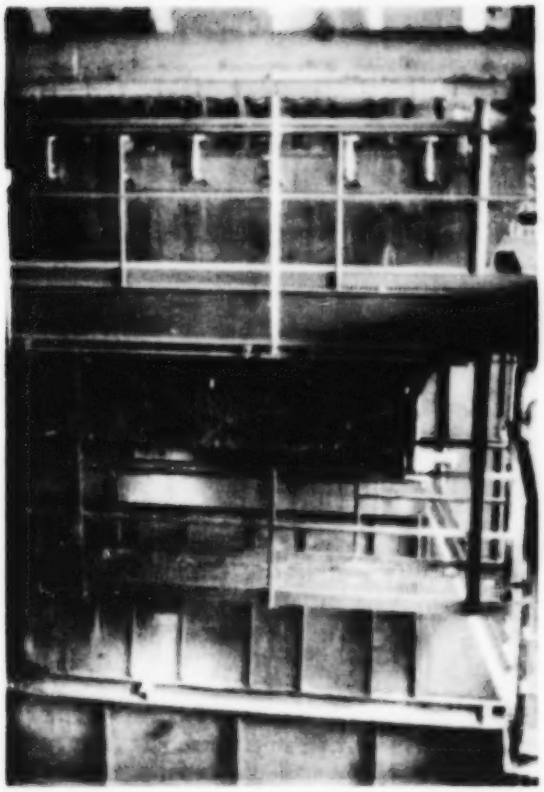
Photo No. 6 Close-up view of a venturi throat showing the motorized mechanism which drives the throat blocks in order to vary the throat's gap. The slurry spray piping is shown at the top.

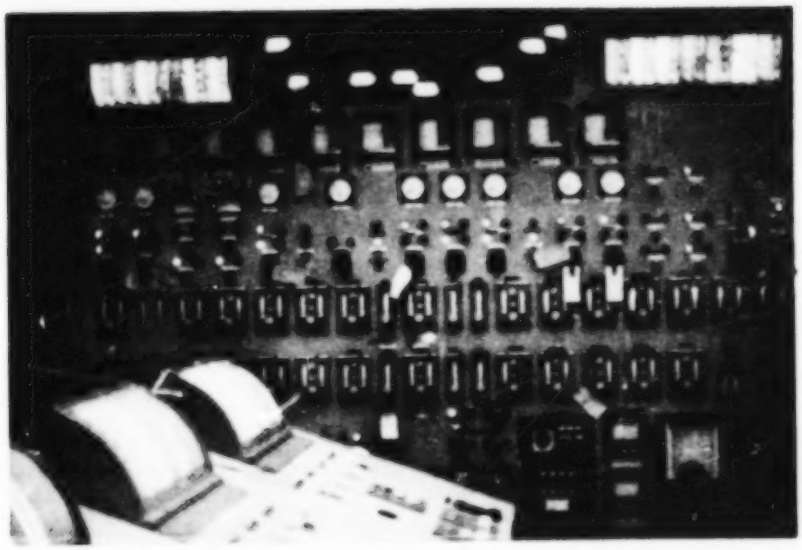
Photo No. 10 The FGD instrument panel which is located in the boiler control room. Some of the important instruments on this panel are the SO_2 inlet and outlet concentrations, pH meters and pump controls.

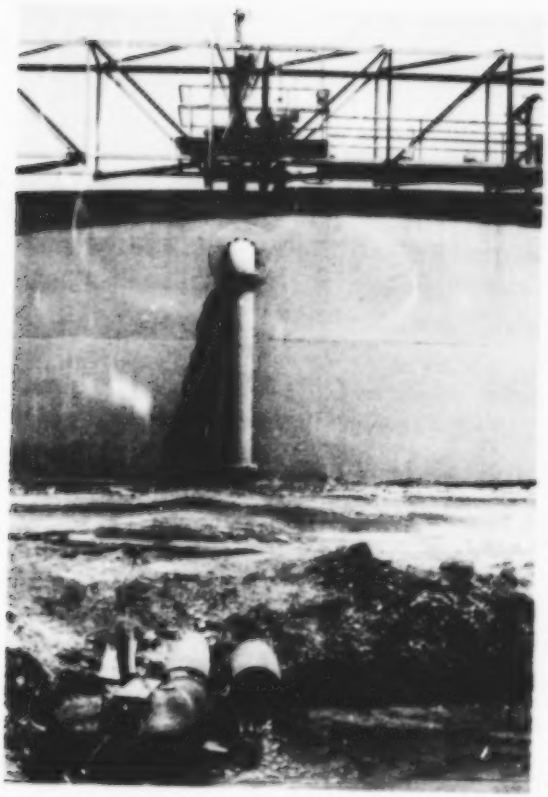
Photo No. 13 Side view of the clarifier tank showing the overflow pipe discharging in the nearby pond. This water is further clarified in the pond and recycled to the FGD system. The underflow pipe is discharged to a holding tank located near the clarifier tank.

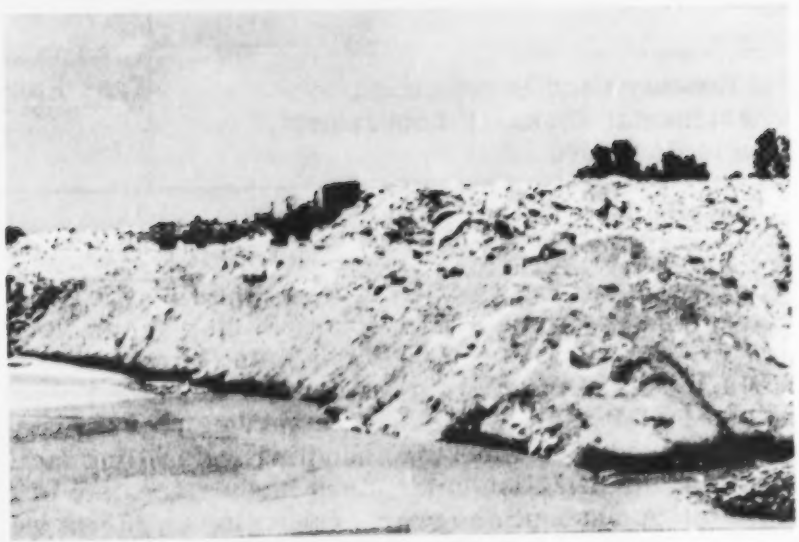
Photo No. 18 The stabilized sludge which solidifies in about one week depending on weather conditions is excavated and piled as shown in this picture and hauled away for disposal in an off-site sanitary landfill.
